REFERENCENIST
PUBLICATIONS**NBSIR 85-3158**

Fire Performance of Interstitial Space Construction System

J. Randall Lawson

May 1985

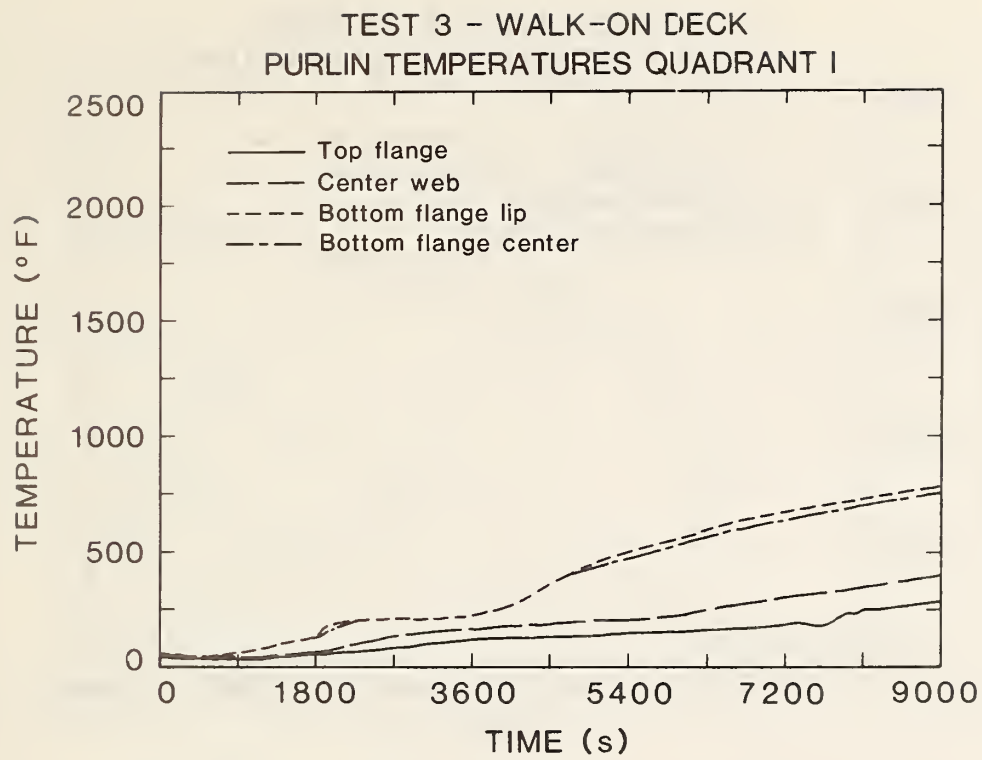
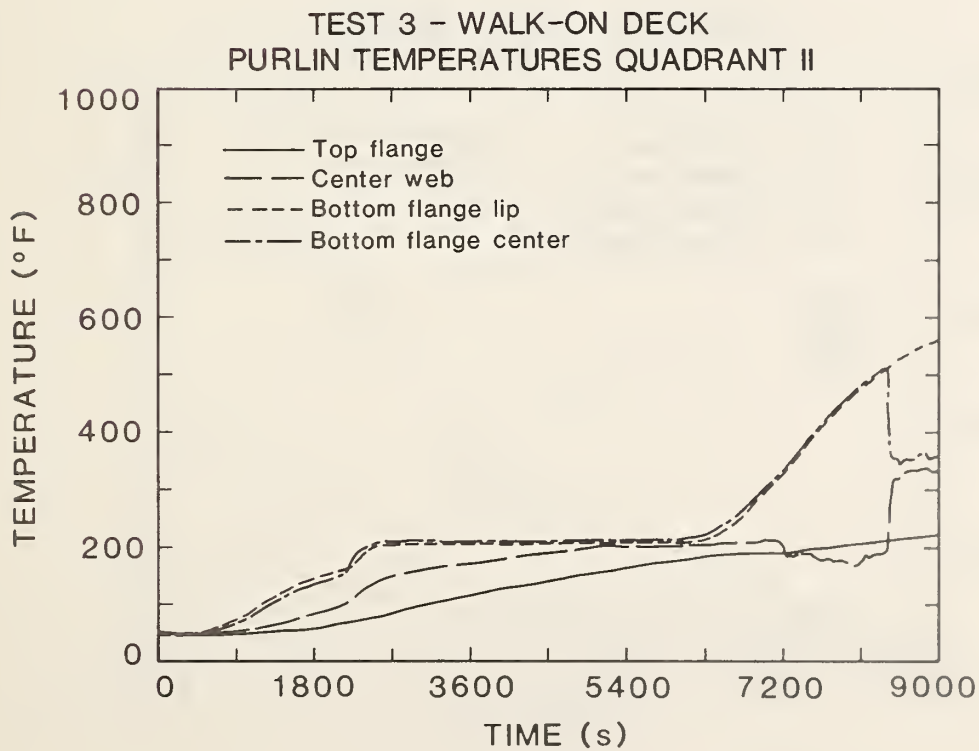
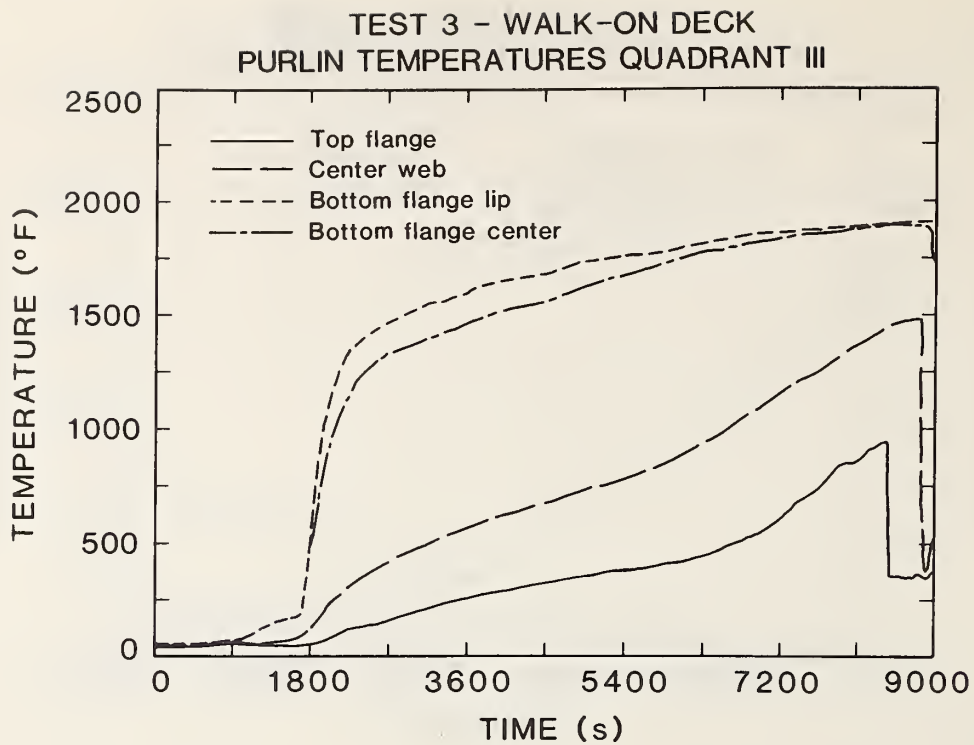
Walk-on deck purlins did not achieve the same degree of success. This is shown in figures 128 to 131. The purlin which crosses quadrants III and IV experienced peak temperatures in excess of 1800°F on the bottom flanges. The earliest single point critical temperature limit was reached in quadrant III at about 36 minutes into the test. The two measurement locations on this purlin also show failures for average temperature. These failures occurred at 1 hour 11 minutes for the purlin location in quadrant III and 1 hour 53 minutes for the purlin location in quadrant IV. Test observations noted in section 8.1.2 show that these critical temperatures relate directly to the fireproofing dropping off the purlin. This purlin, which failed, did not have its bottom flange wrapped with wire mesh before the fireproofing was applied. The other purlins that did have wire mesh wrapping performed well, and it indicates that it is important for purlin protection when glass fiber formboard is used in a system of this design. The observation noted in section 8.1.2 stating that large gaps were observed between fireproofing and the gypsum deck, where the glass fiber board burned out, supports this conclusion. The subpurlins' temperatures are shown in figures 132 and 133. These construction elements also experienced significantly high temperatures. However, it should be remembered that the subpurlin flanges

Figure 128. Walk-on deck purlin temperature quadrant I, test 3

Figure 129. Walk-on deck purlin temperature quadrant II, test 3

Figure 130. Walk-on deck purlin temperature quadrant III, test 3
